Report on

Road Safety Audit of Pilot BRTS Corridor at Pune

Submitted to
Pune Municipal Corporation

Submitted by
Transportation Systems Engineering Group
Department of Civil Engineering
Indian Institute of Technology Bombay
Powai, Mumbai - 400 076

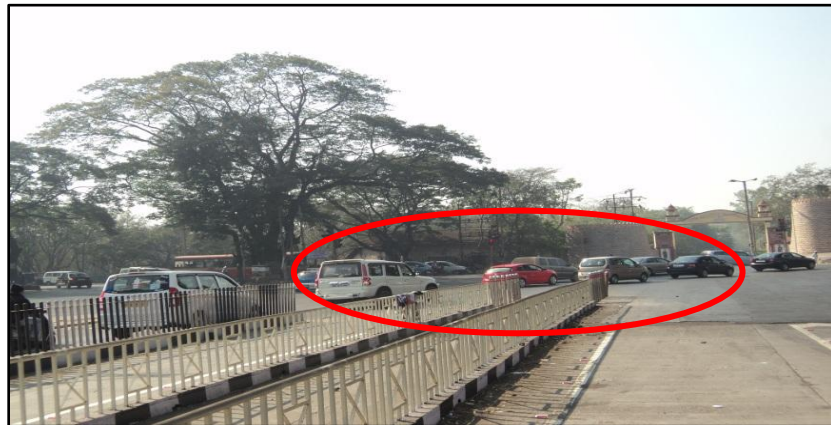
Observation 4: Safety issues at Bombay sappers junction (T junction)

(i) Absence of road markings and chanalization to segregate the movement of buses and other types of vehicles.

(ii) Absence of bus lane sign board

The junction improvement measures have to be implemented as per the details given in PMC design drawings.

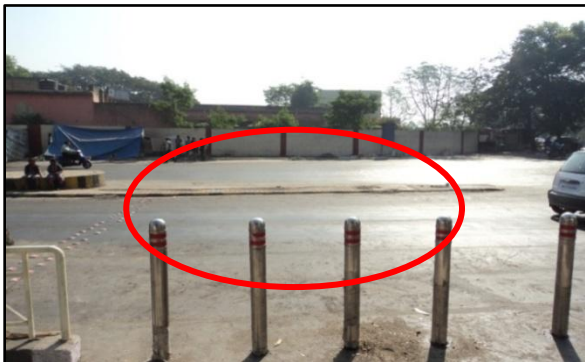
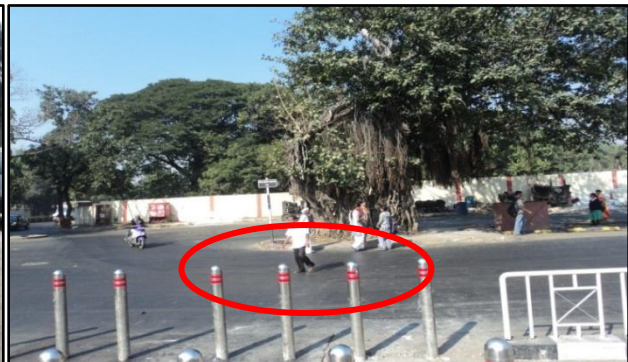
(iii) Improper pedestrian crossing facilities, like pedestrian signals, markings etc., at bombay sapper's junction.

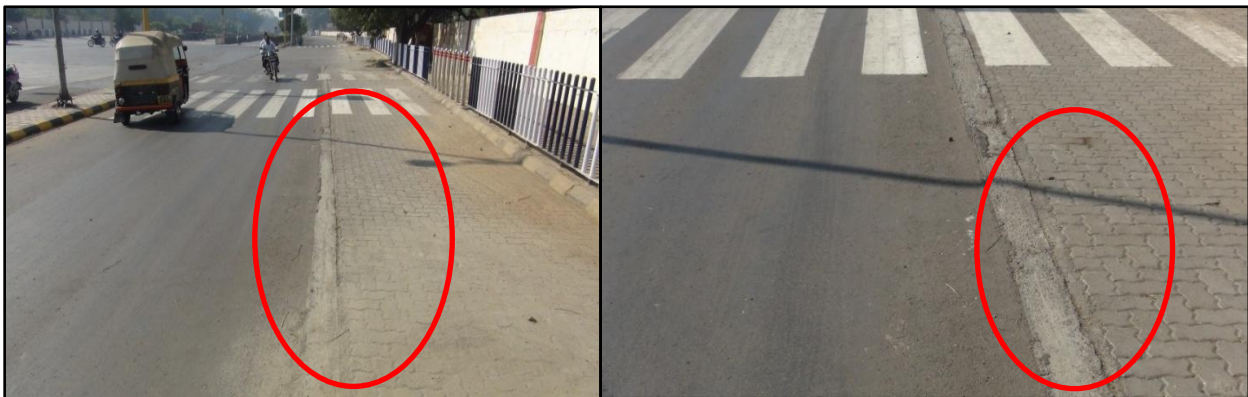
Observation 6: Pavement surface leveling difference/undulation on the service lane near District Home Guard Junction

- **Improper leveling** of the service lane or pathways making movement difficult particularly for the physically handicapped pedestrians. (Example: near District Home Guard Junction)

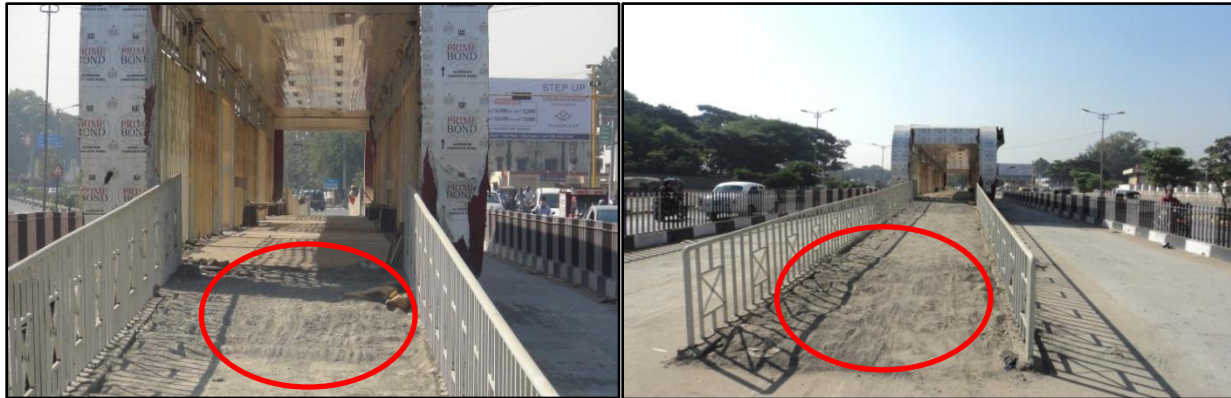
Observation 8: Incomplete ramp construction and seating facilities at bus station of District home guard junction

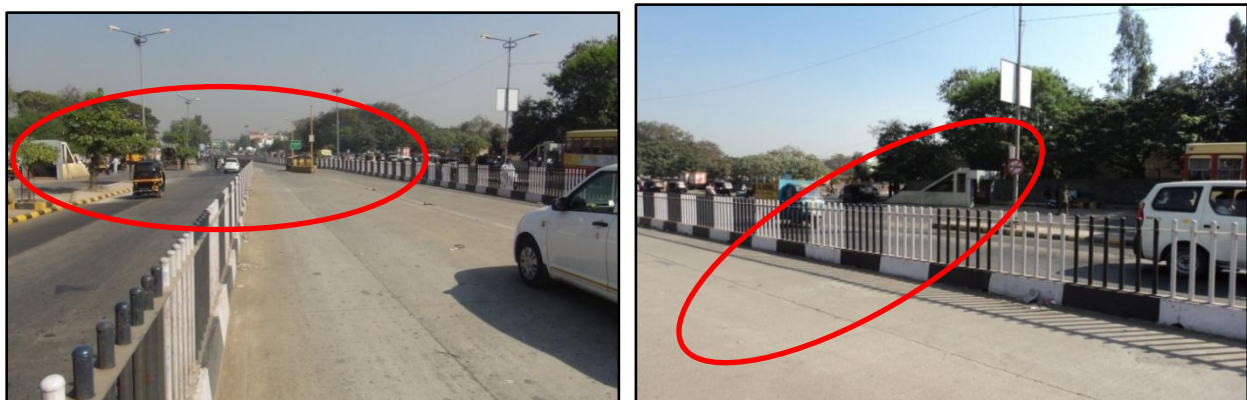
Observation 9: Pedestrian accessibility from bus station to Subway is missing near district home guard junction

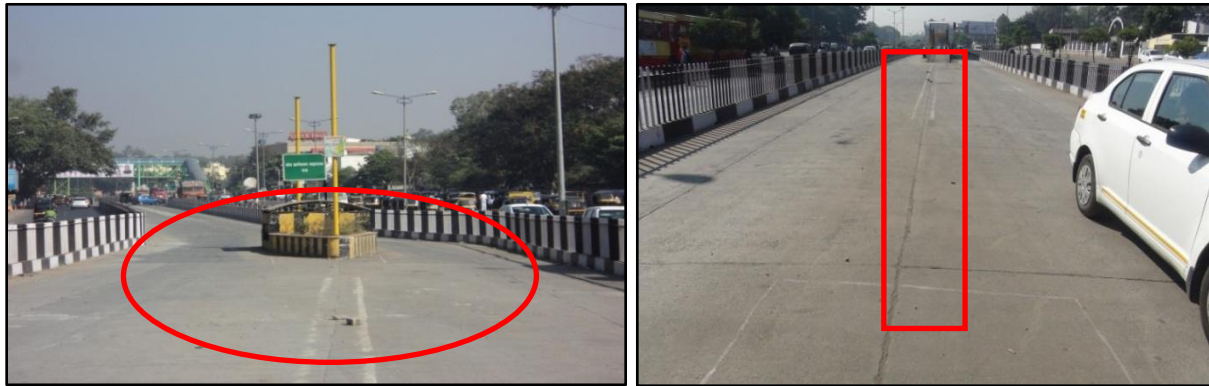
Observation 10: Major obstruction on the BRTS corridor, absence of bus lane markings

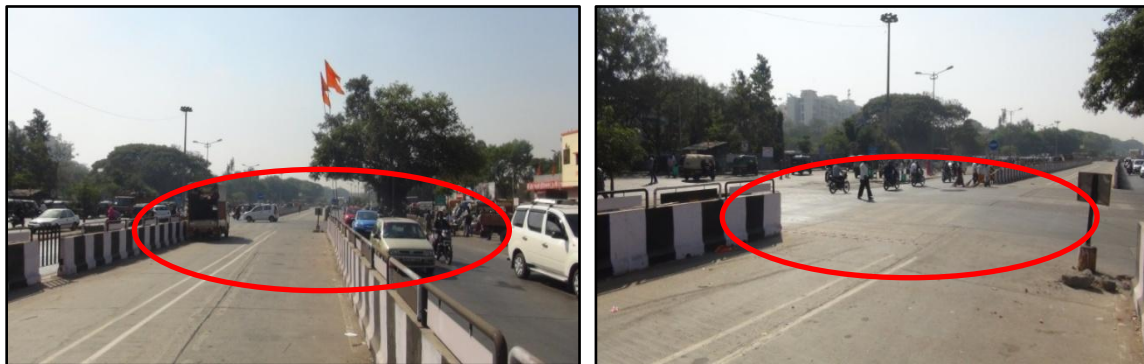
Observation 11: Unwanted Midblock opening - Near MES pump house. These openings should be closed before BRTS operations.

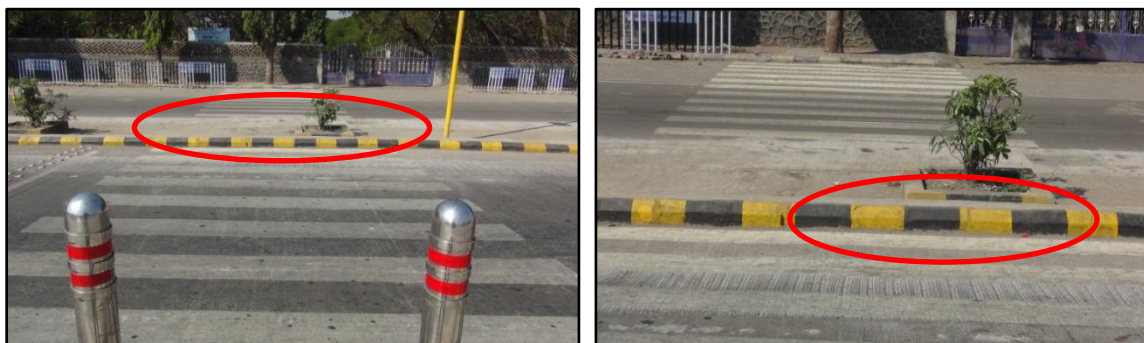
Observation 12: Level difference/discontinuity in pedestrian zebra crossing near bus stations (unsafe for physically challenged people)

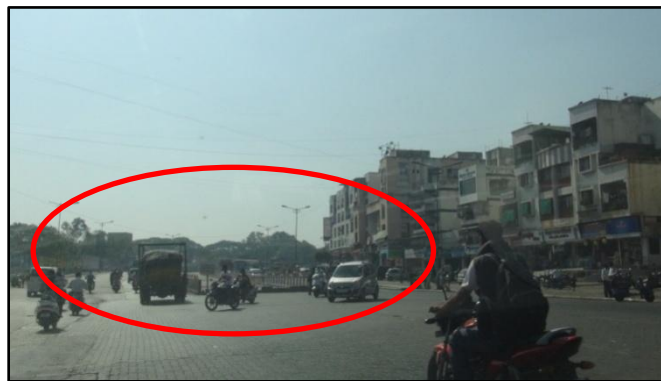
Observation 19: Absence of segregation through marking and information signs at starting/ending point of the corridor which can cause merging/diverging conflicts near Vishrantwadi.

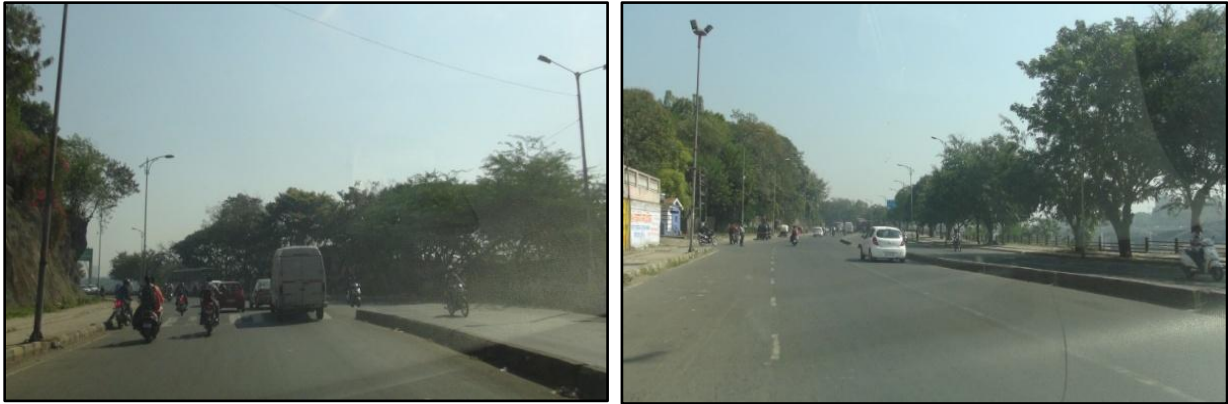
Observation 20: Mixed traffic zone forming bottle neck (from Sadal Baba to Yerwada junction)

Followed by the Sadalbaba bus top, there is a mixed traffic stretch of 900 m, where special safety measures to guide the BRTS and vehicles have to be taken along with proper signal systems, marking and sign boards. Similarly the zone where the mixed traffic road turns to start with Yerwada-Kharadi corridor needs to be focused on in

terms of safety. Near Sadalbaba junction the road width on the left side is 8.4 m and on the right side is 6.3 m making it unsafe for movement of BRTS buses and vehicles.

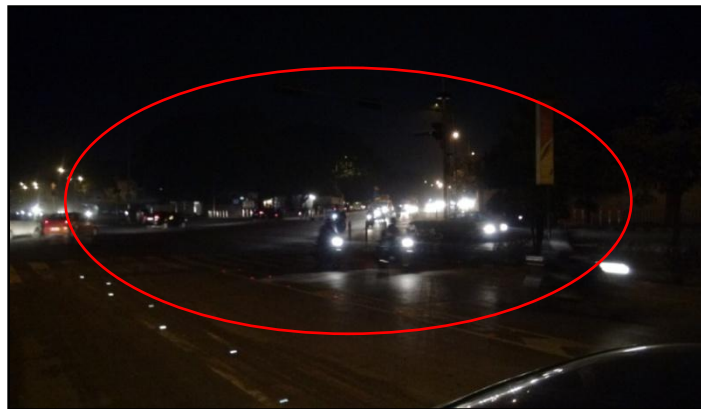
Observation 21: Insufficient lighting facility at Ambedkar society junction.

High mast lights at this location were not working which needs to be replaced.

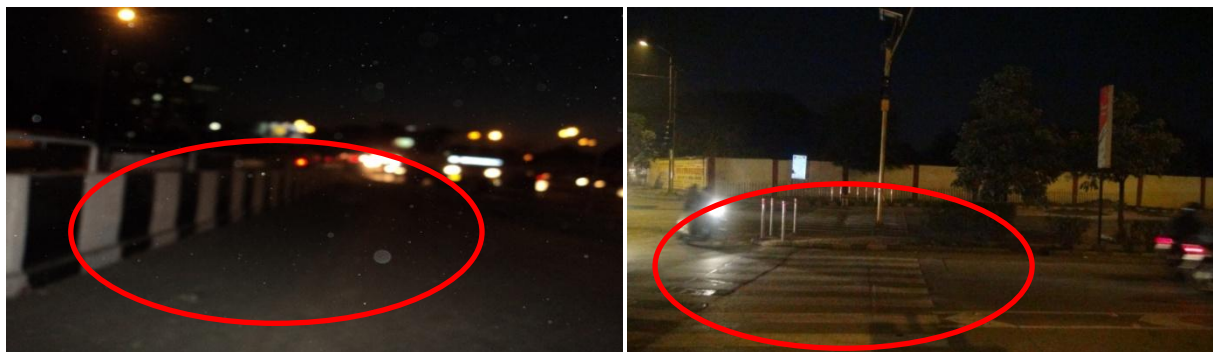
Observation 22: Absence of cat eyes/reflectors, futurlux and lack of lighting facilities.

Down lighters need to be provided here.

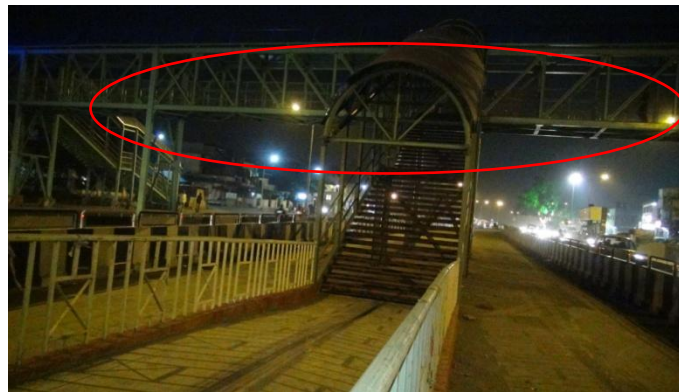
Observation 24: Improper lighting facility on the Foot over Bridge – MES Pump House.

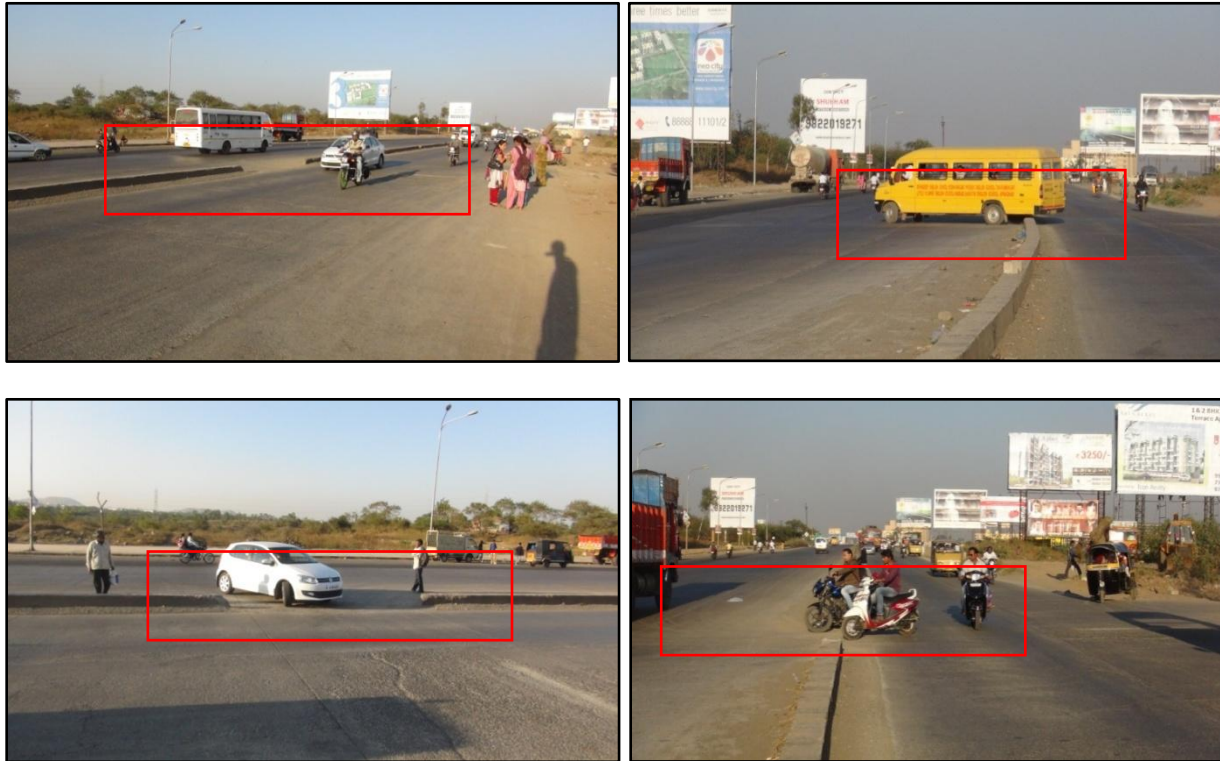
Observation 25: Unwanted mid block opening near 1st Bus station at Kharadi. This allows vehicles to take U turns and pedestrians to cross the road, thus results more conflict points and affect BRTS movements.

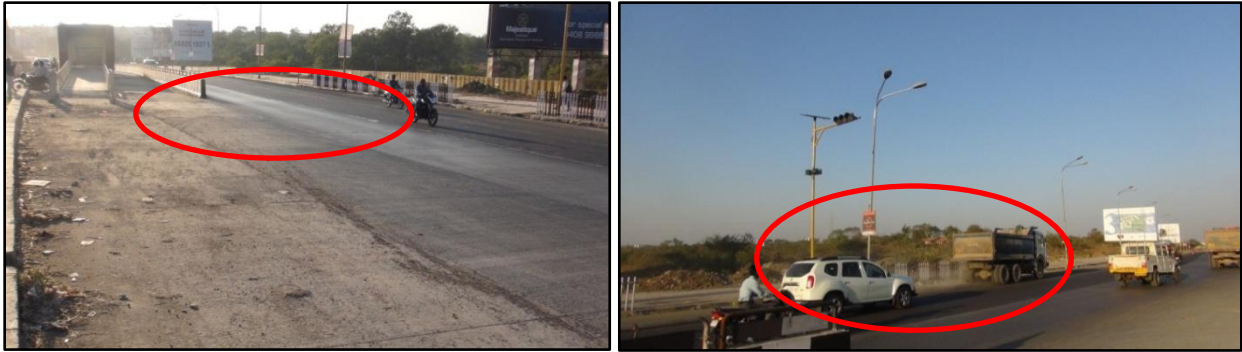
Observation 27: Absence of proper marking/sign boards at location where BRT & other vehicles are merging together.

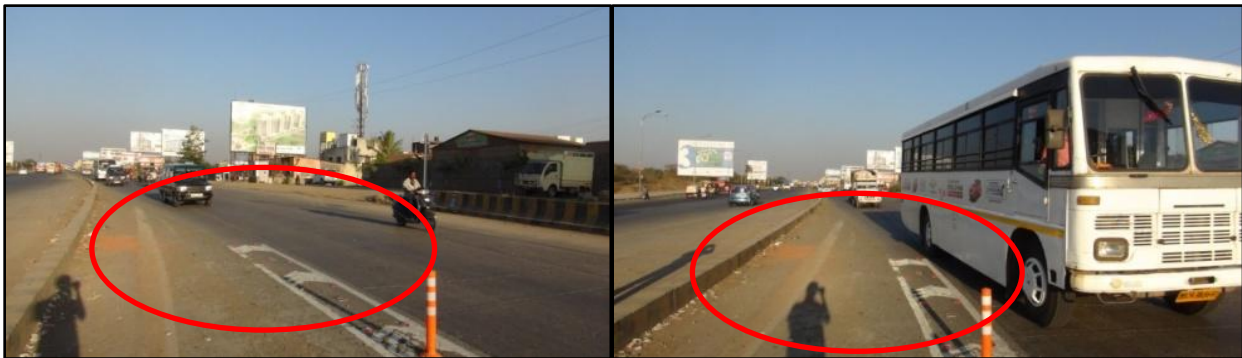
Observation 28: Absence of marking to guide BRTS buses to access bus station and absence of BRTs information sign

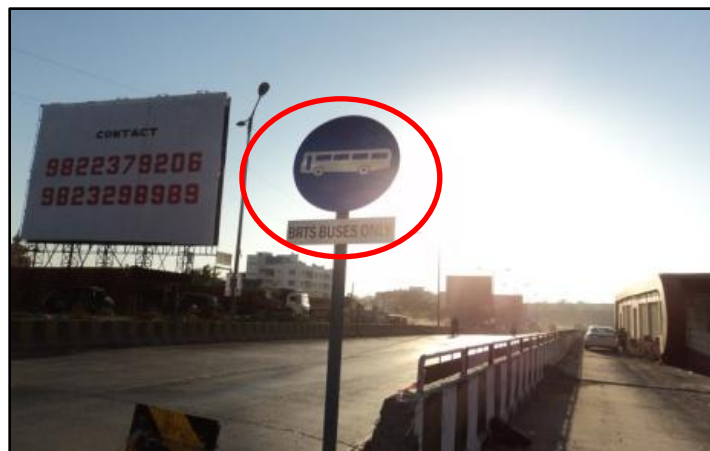
Observation 29: Non standard bus station sign. This bus station sign should be according to IRC 67: 2012.

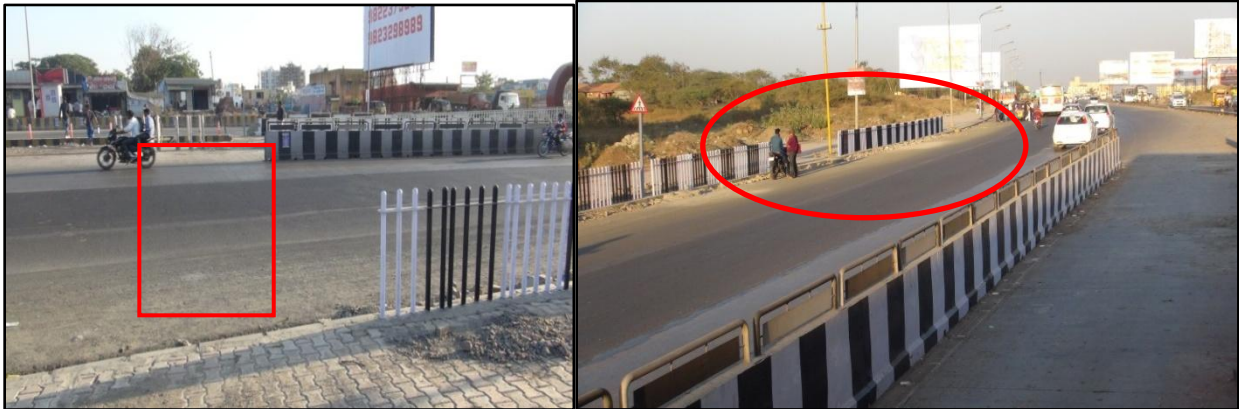
Observation 30: Improper pedestrian crossing facilities around 1st Bus station at kharadi (absence of pedestrian signal crossing markings etc.)

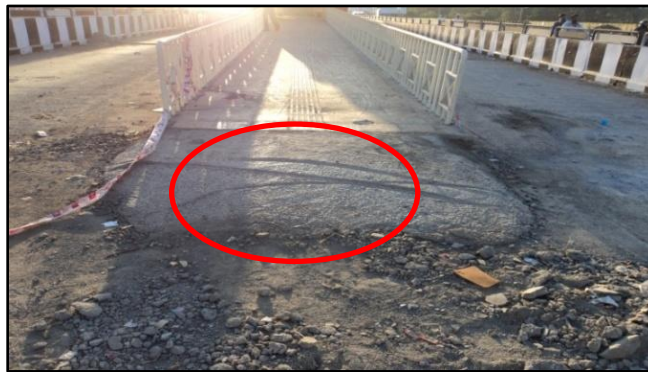
Observation 31: Absence of platform or flooring for pedestrian movement (difficulty for physically challenged)

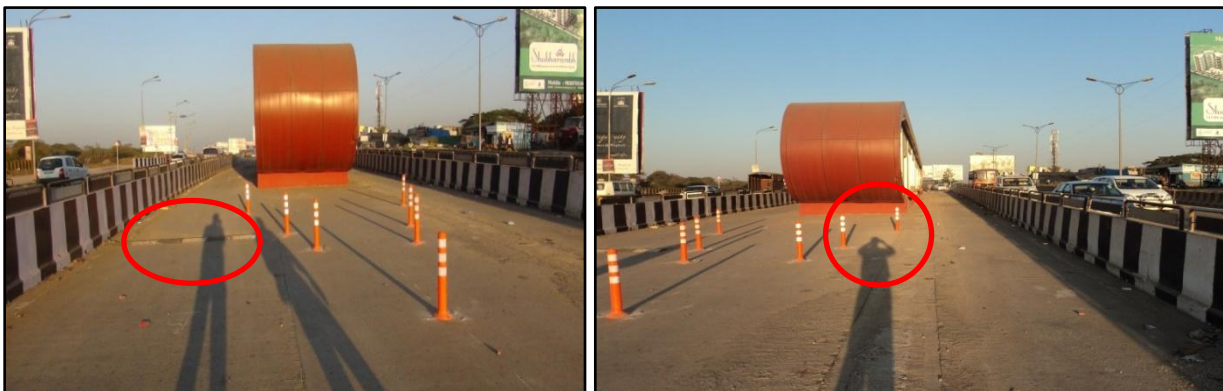
Observation 32: At 1st Bus station, Kharadi junction, improper alignment of dividers can cause obstruction for the smooth movement BRTS, unnecessary rumble strips and chevron, bus lane markings are missing.

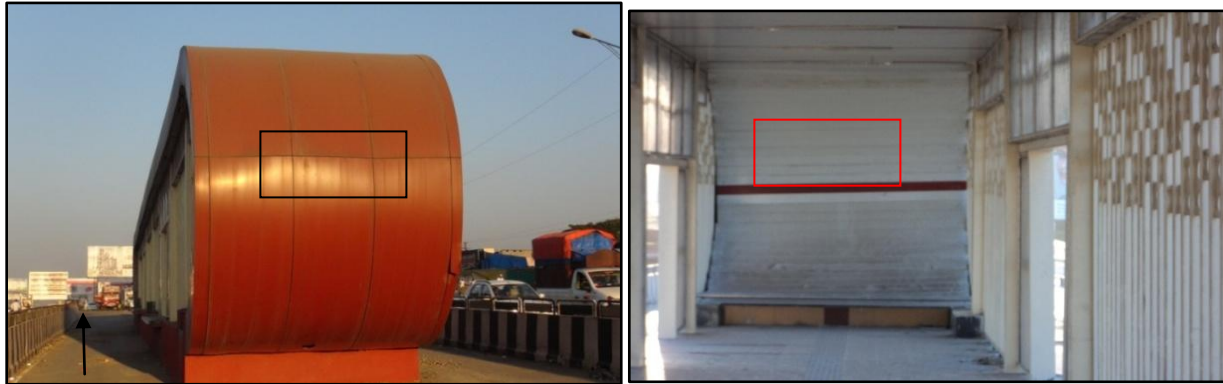
Observation 33: There is no possibility of getting information about bus arrival at bus stations (particularly non ramp side). Information system needs to be installed in each bus stations providing bus schedule details. Glass panel can be made to increase visibility of buses for users.

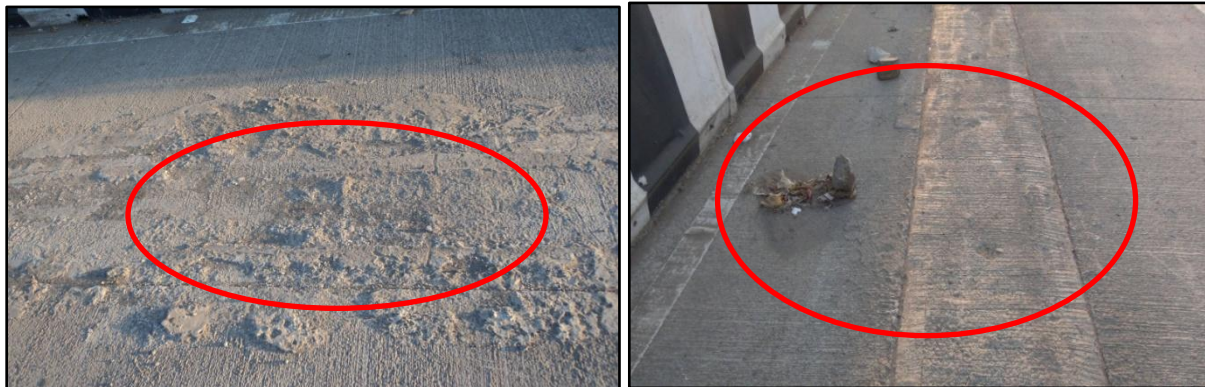
Observation 34: Road surface irregularities are observed on the BRT corridor near Kharadi junction bus station.

- Absence of **speed limit signs** along the BRTS corridor.
- Improper **road surface** at few places on the BRT corridor (Example: near Kharadi junction bus station)

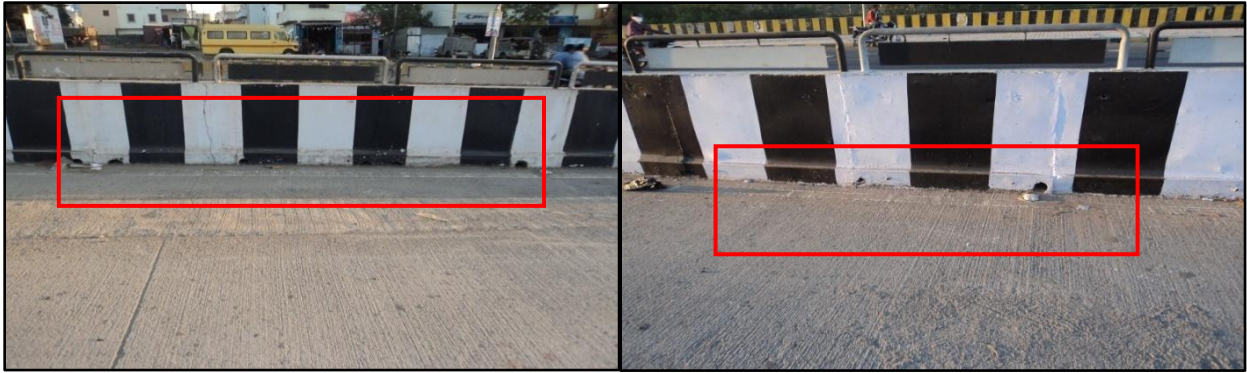
Observation 36: Temporary blockages of the drainage holes and cleaning needs to be done as this may result in possibility of water logging during rainy seasons.

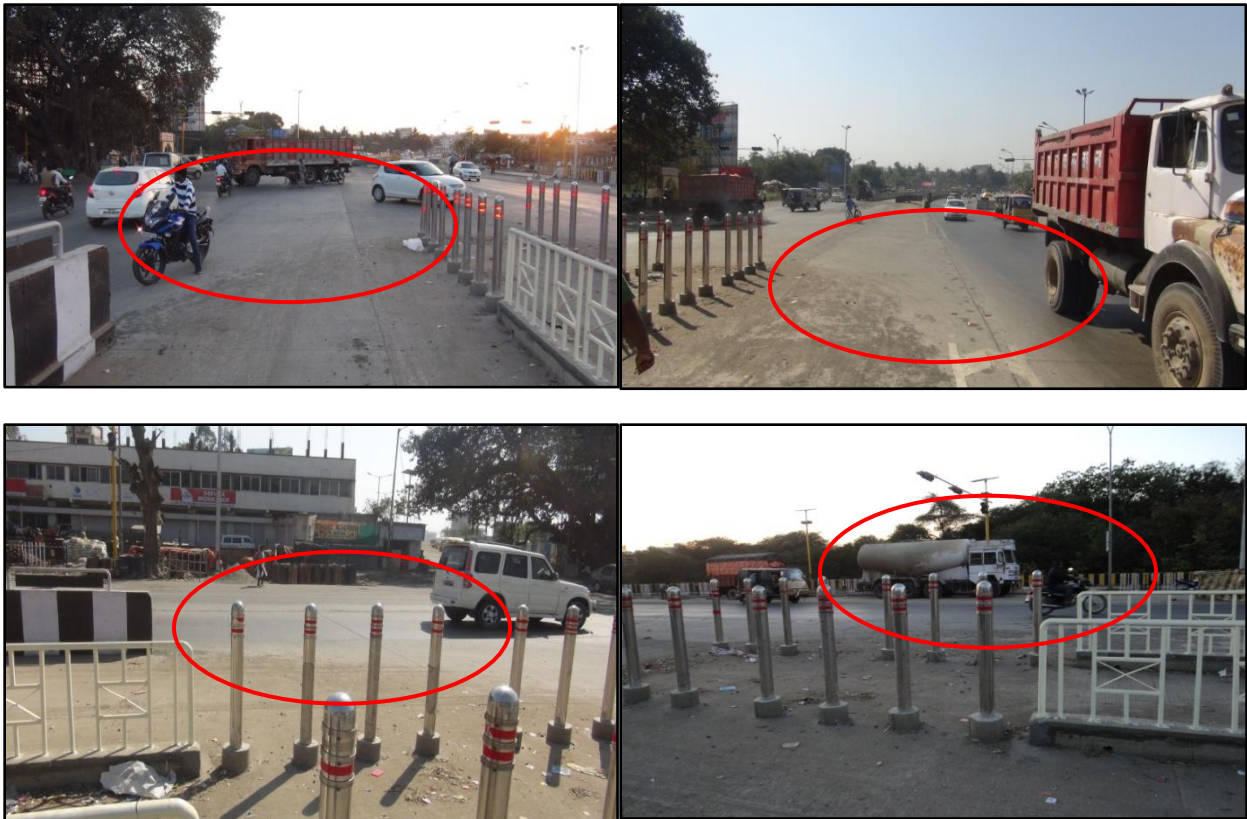
Observation 37: Absence of divider, pedestrian crossing facilities, markings and separate signal for BRTS at Indian Oil petrol bulk junction, Kharadi

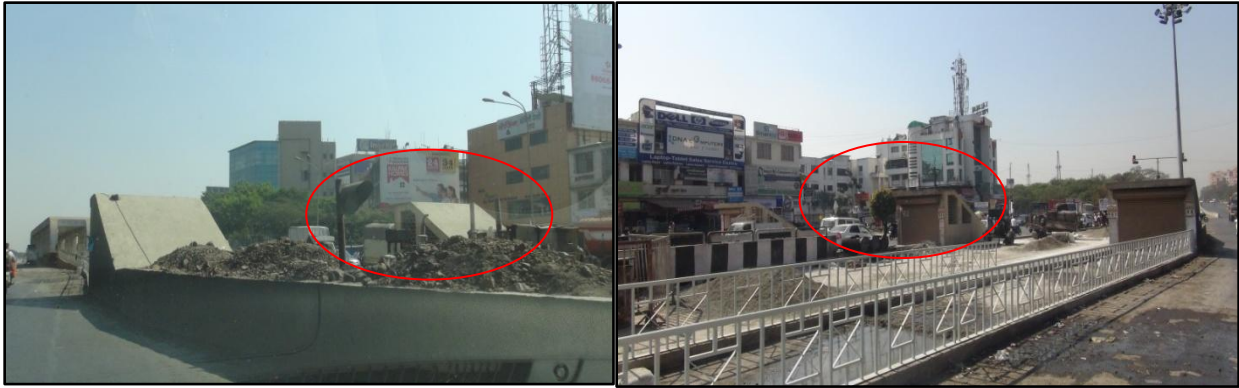
Observation 45: Ongoing construction for connecting the subway to the BRTS lane should be completed before operation at Viman nagar junction (near Inorbit mall)

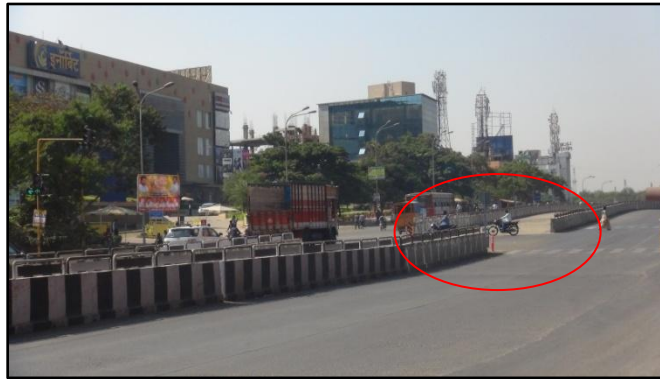
Observation 46: Unsafe Midblock opening near four point hotel junction

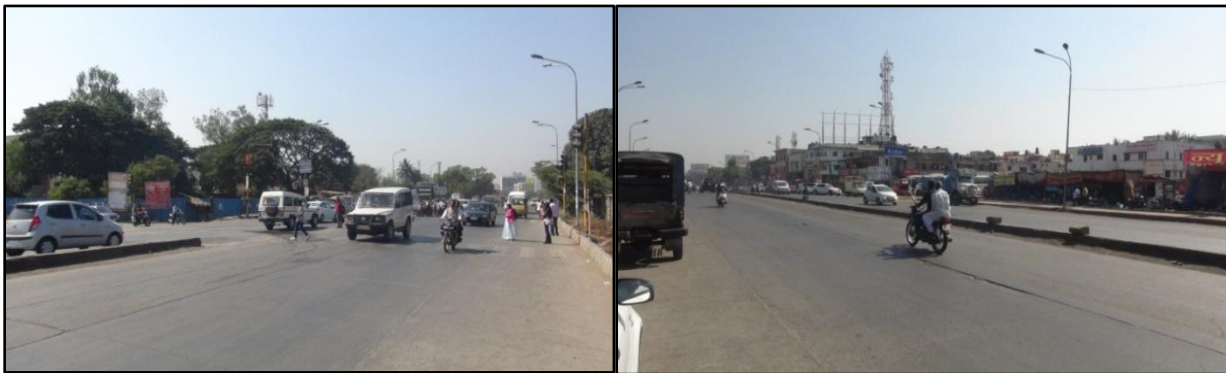
Observation 47: Markings/ signanges need to be provided to segregate BRTS lane near Shastri nagar.

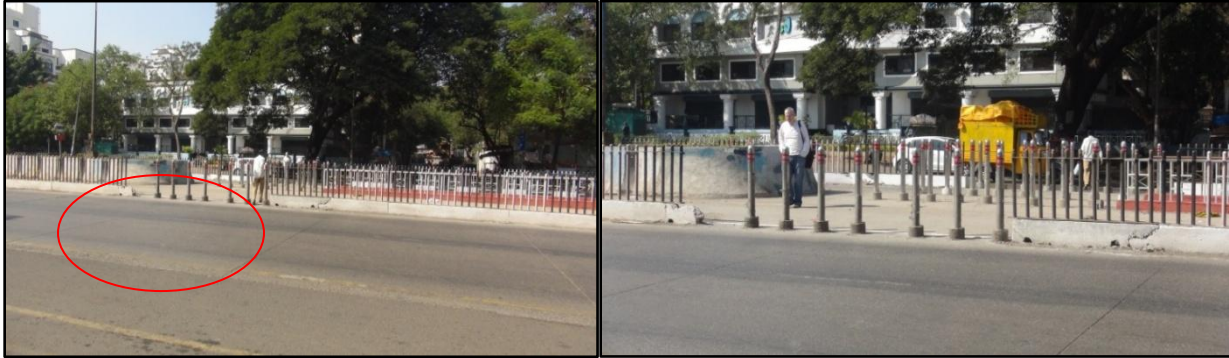
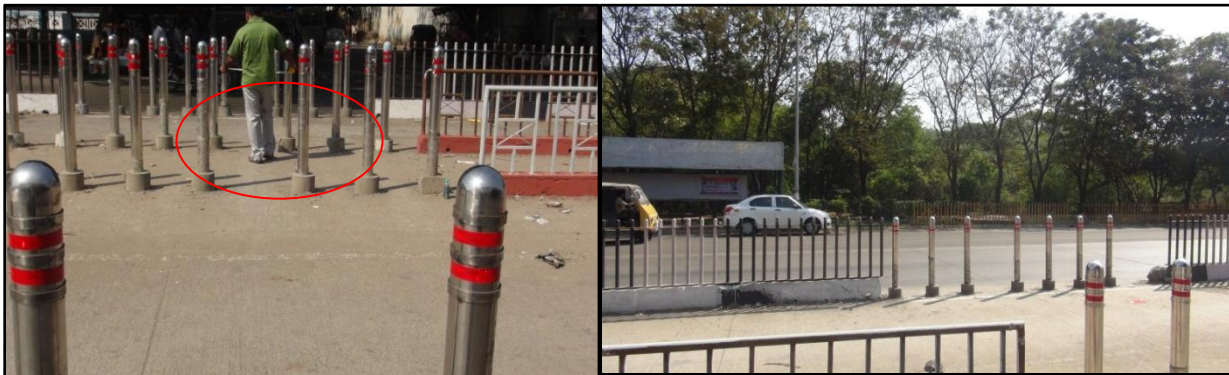
Observation 48: Absence of pedestrian crosswalk markings/highlighting or facilities near Gandhi Nagar and Ramwadi Jakatnaka

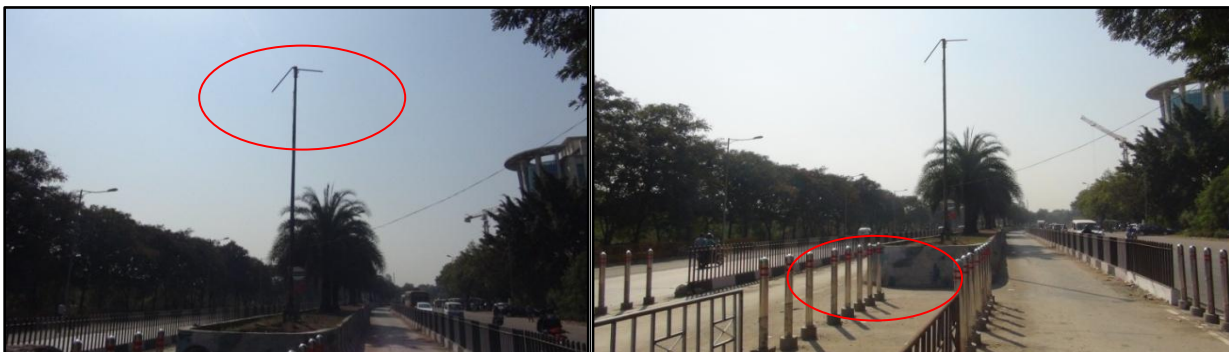
Observation 49: Missing lighting facilities and warning reflectors or sign boards to show the presence of median

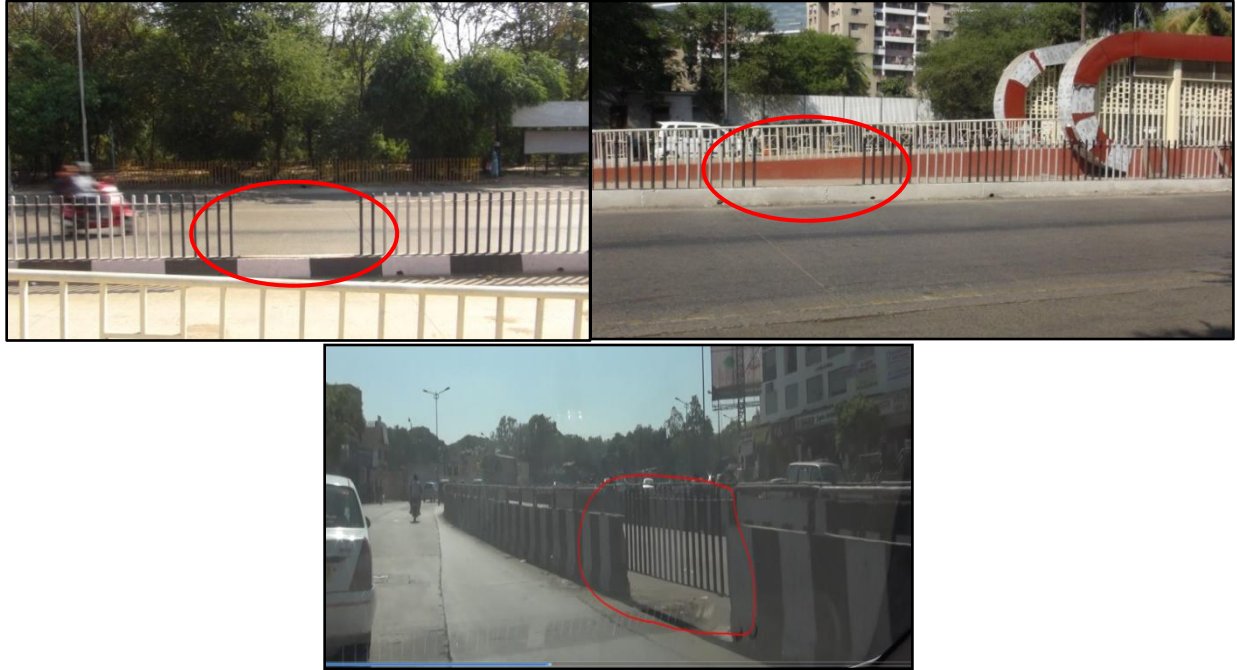
Observation 50: Improper barricading near Gandhi Nagar and Ramwadi Jakatnaka

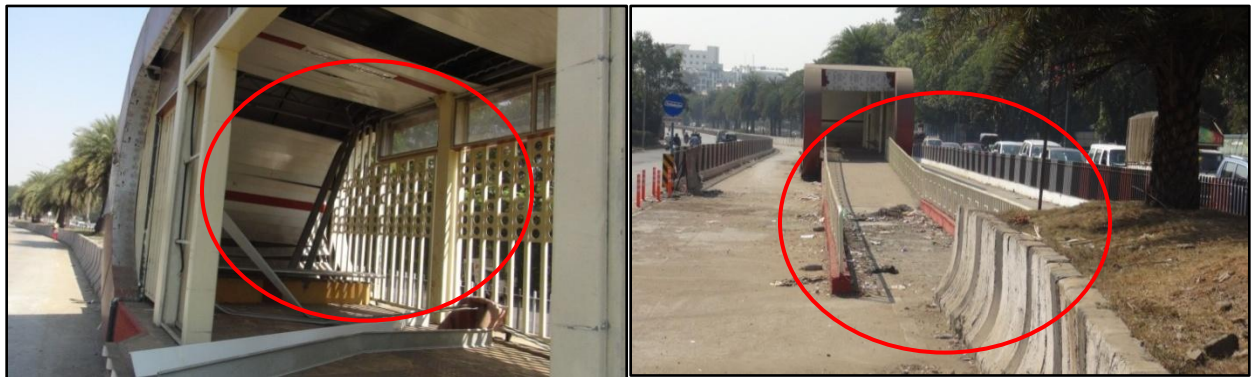
Observation 51: Inside facilities of bus station near Prince Regent is incomplete and presence of median is obstructing the BRTS foot path

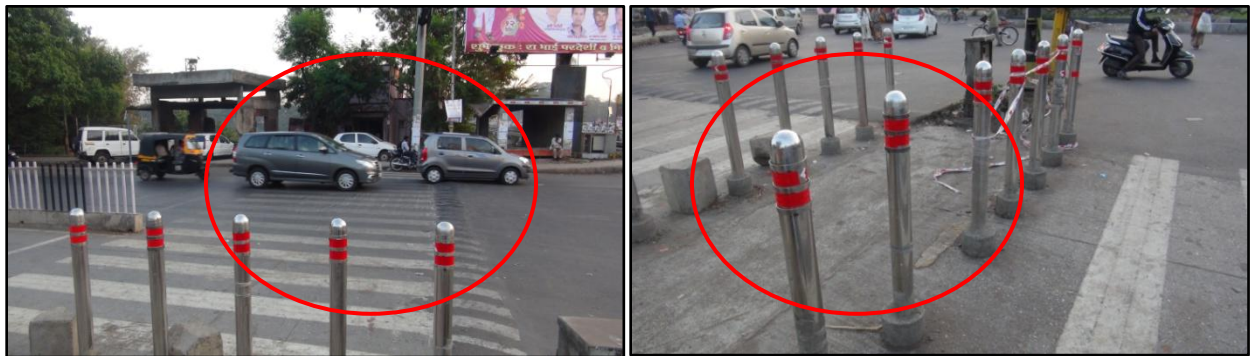
Observation 52: Absence of signals, sign boards at Yerwada junction

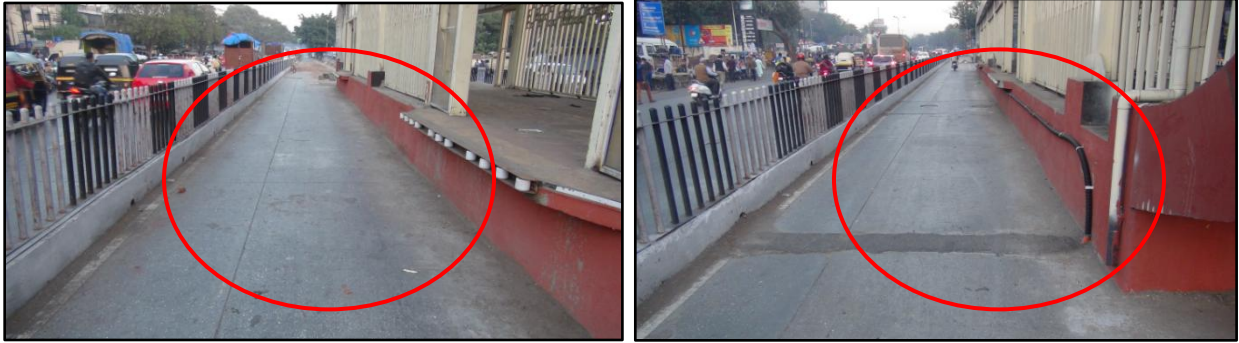
Observation 53: Bus stations with missing highlighting/ yellow markings at Yerwada junction and Hotel Prince Regend junction (Gunjan Junction)

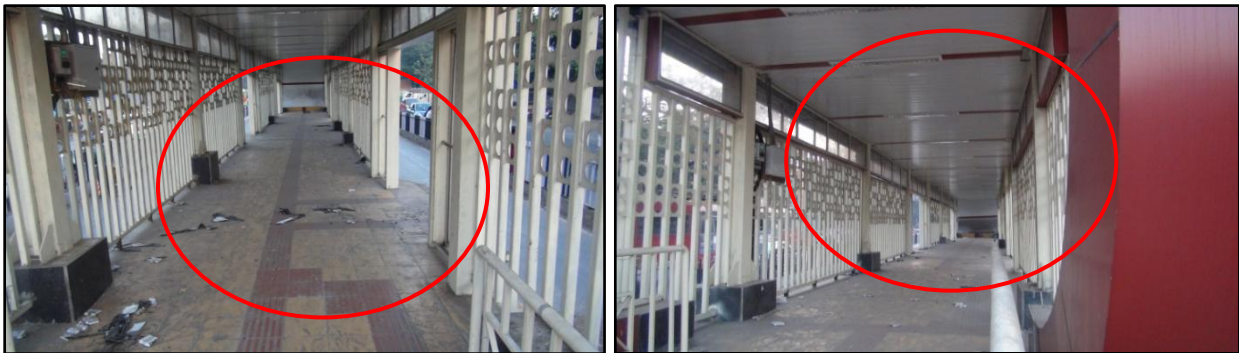
Observation 54: Bus stations at Yerwada junction and near Hotel Prince Regend junction (Gunjan Junction) have no seating arrangements and ticket collection booths (Incomplete construction)

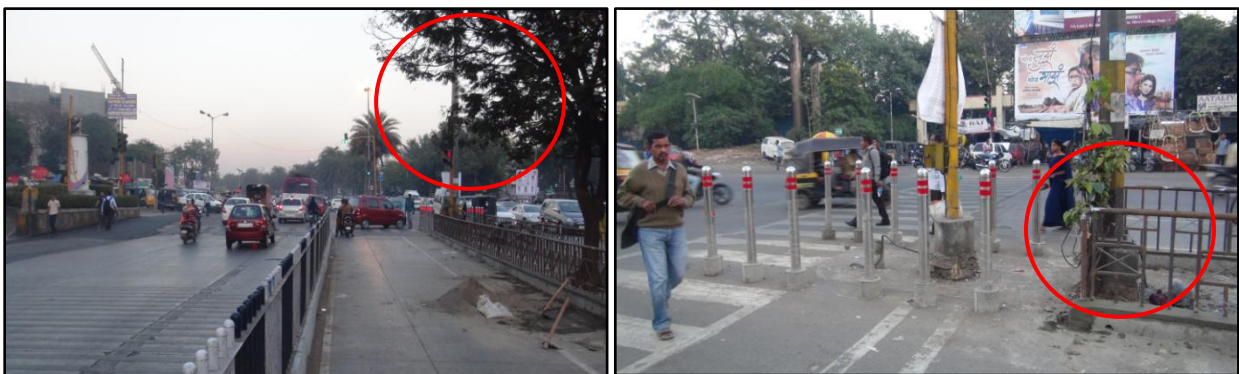
Observation 55: Obstruction caused by Tree and pole on the crosswalk from bus station at Gunjan Junction

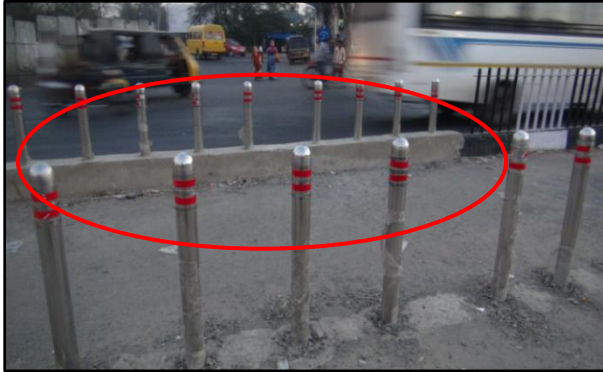
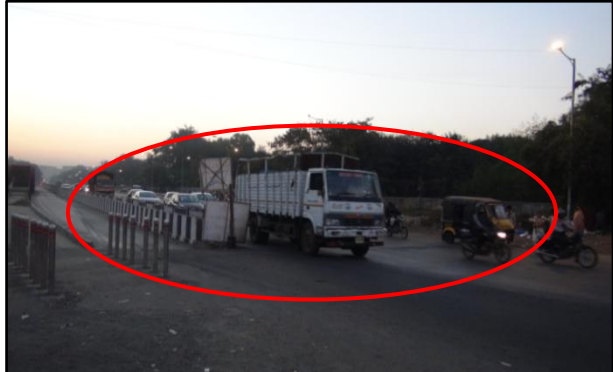
Observation 56: Near Hyatt unsafe pedestrian crossing facilities like absence of signal, sign boards, improper bollard gaps, presence of cement base on bollards can be dangerous. This needs to be removed before BRTS commencement.

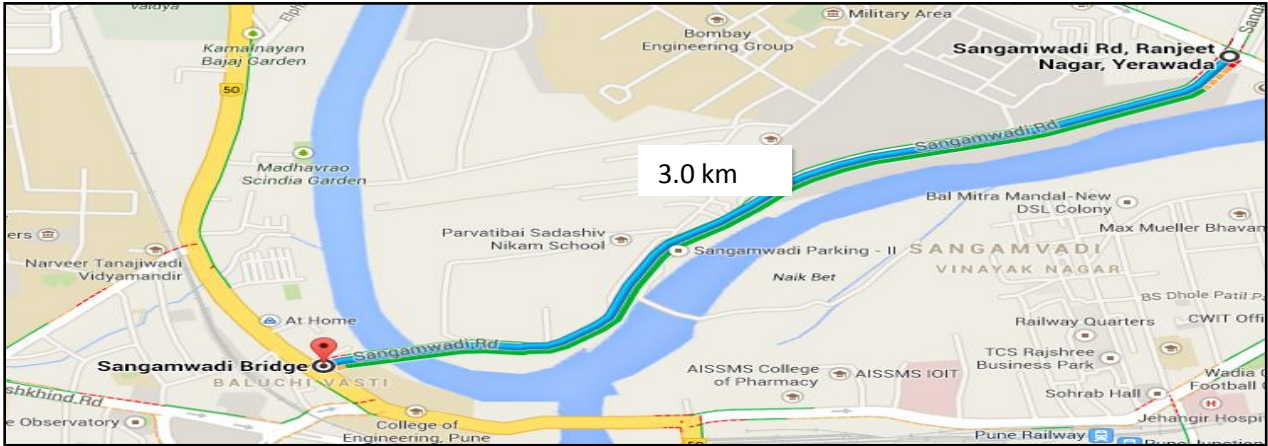
- For this lane, the total lane separator length: 2.0 km
- Construction has been completed for 1.4 km and still for 0.6 km lane separator construction of separator is pending

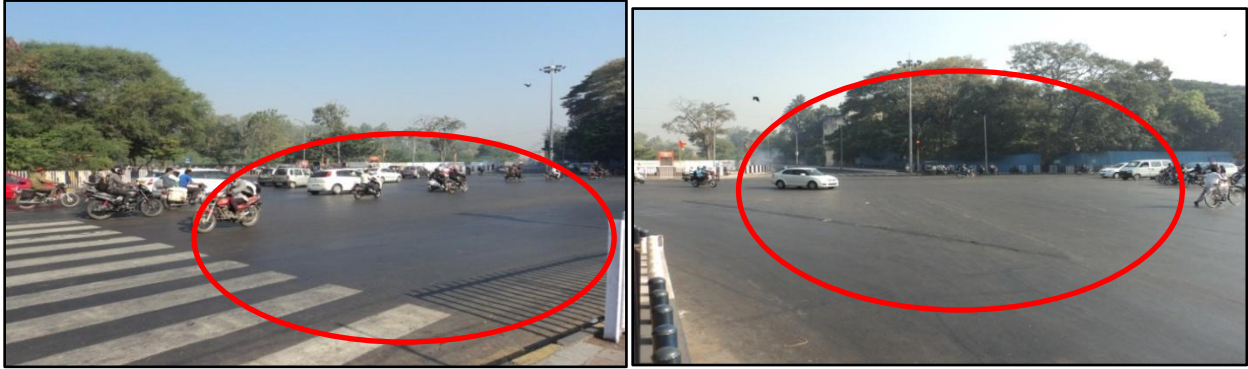
Observation 60: No segregation for BRTS at Sadal baba junction

Vehicles entering corridor 3 (Sadalbaba-Sangamwadi) from bombay sappers turning right and from yerwada corridor turning left can cause conflict and congestion at this junction.

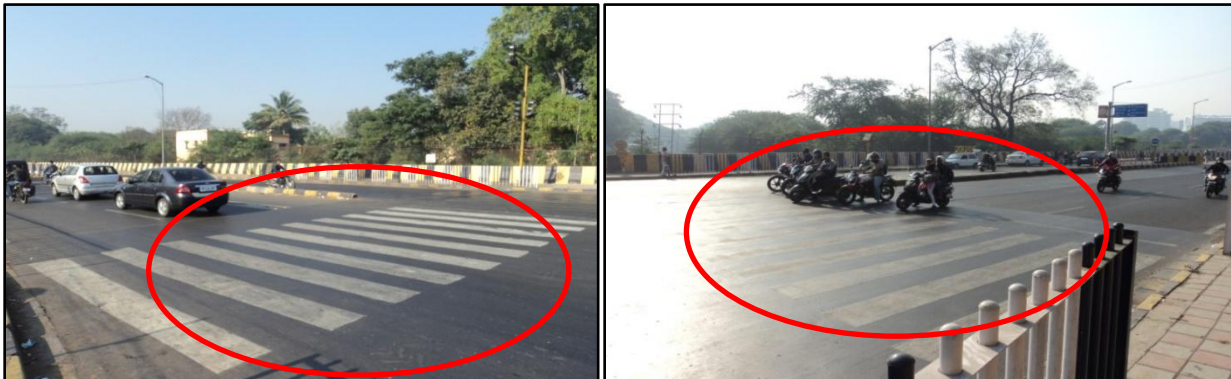
Observation 61: Reflectors, pedestrian sign board and separate signal for BRTS missing at Sadalbaba junction

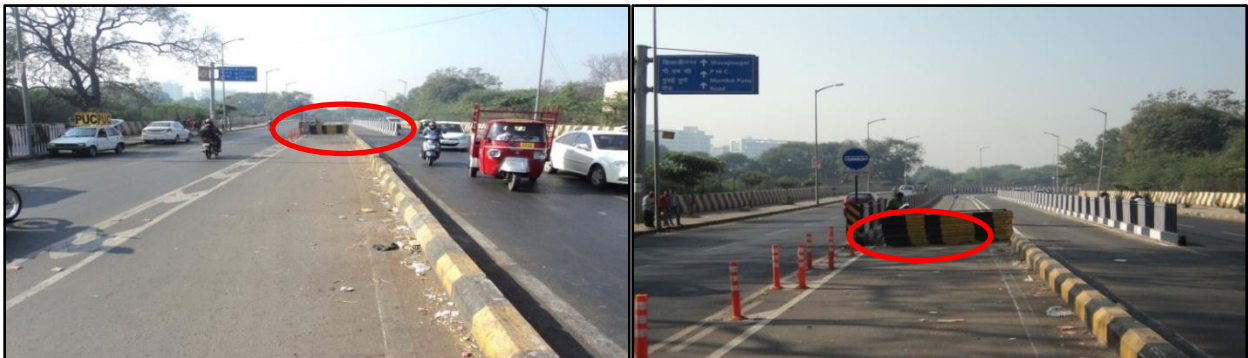
Observation 62: Information board to denote start of BRTS lane is too far near Sadal baba junction

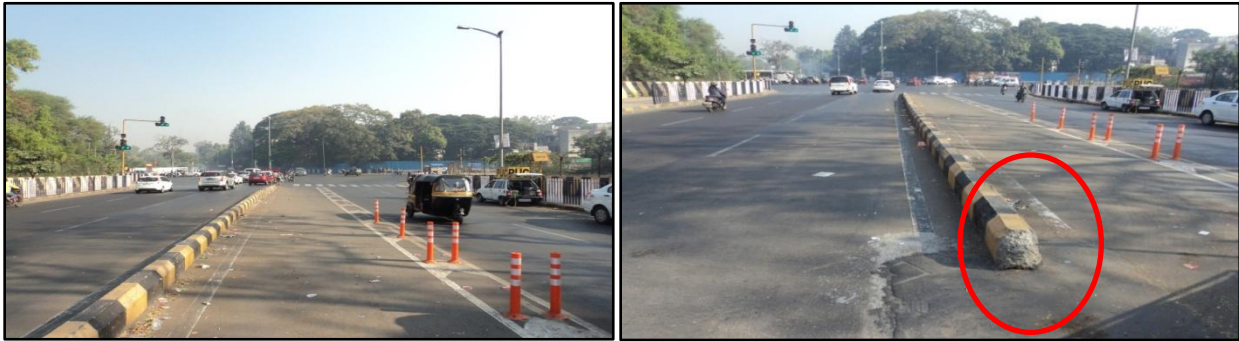
Observation 63: Improper segregation and incomplete median construction of BRTS corridor near Sadal baba junction. This median will be an obstruction during night time and will not be visible.

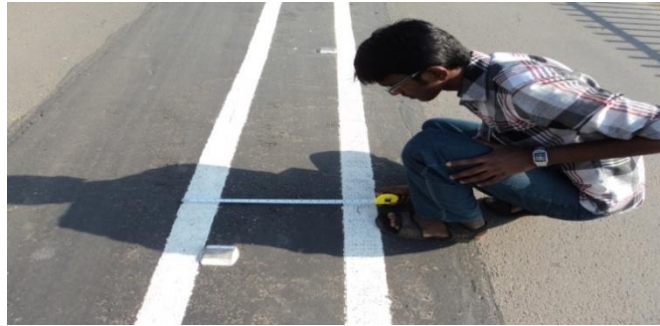
Observation 66: Spacing between two BRTS lanes is in the range of 30-58 cm and it should be maintained throughout the BRTS stretch.

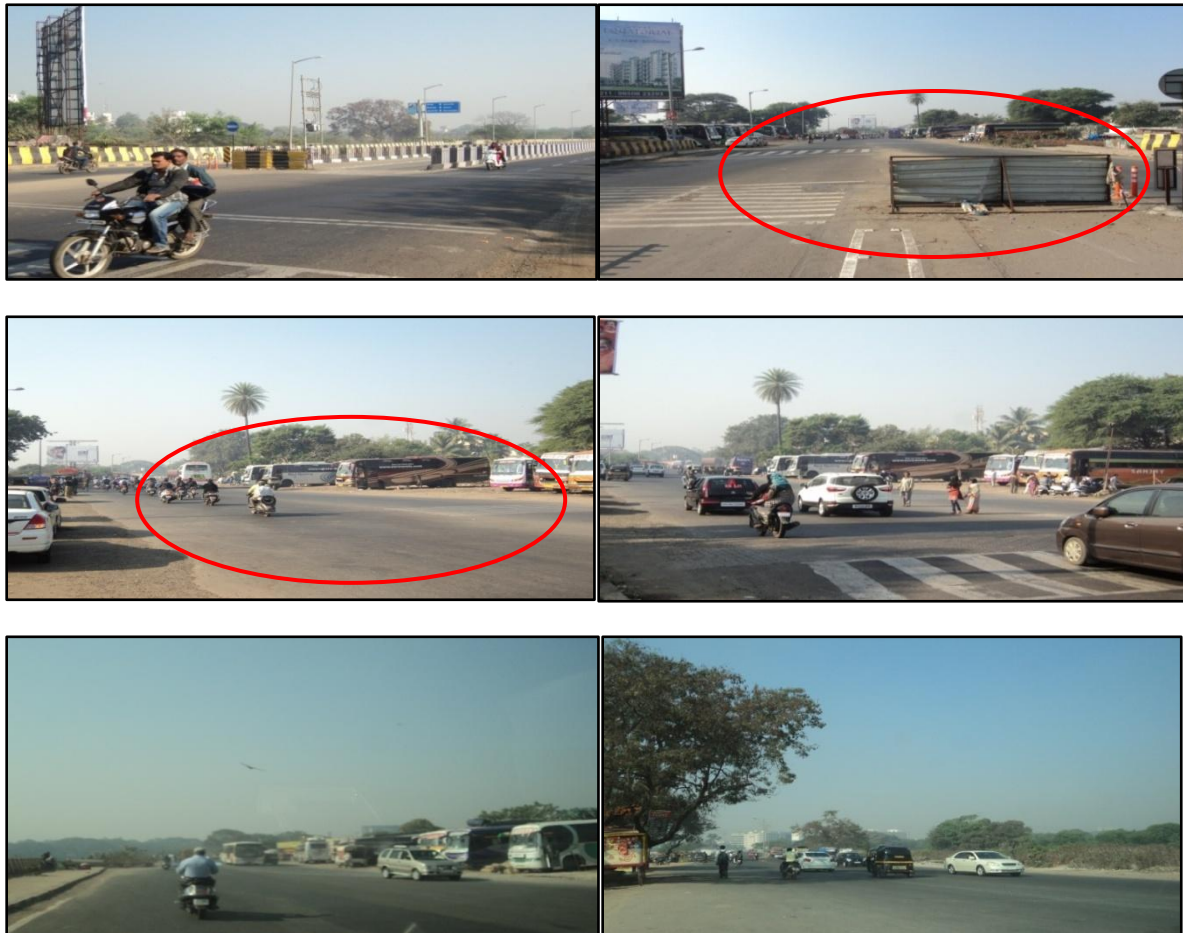
Observation 67: No segregation for BRTS near Inter-city bus terminal that can lead to unsafe mix traffic zone. The road width of this place is 24m.

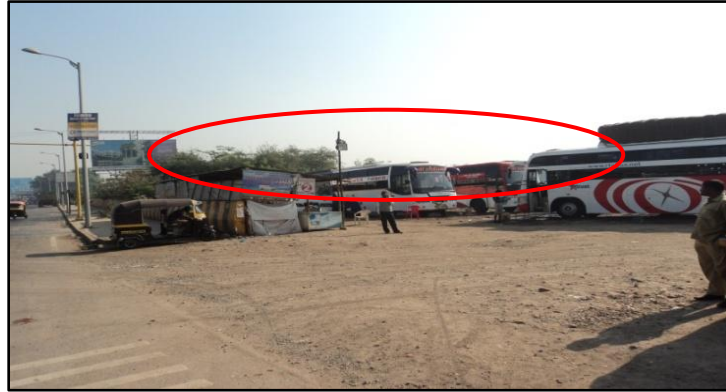
Observation 68: Intercity bus terminal should be relocated to some other place and proper segregation, markings, sign boards should be used for safe and convenient movement of BRT and other vehicle in this zone. The road width should be 30 m for safe BRT and vehicles movement. The movement of intercity buses is likely to create obstruction to BRT flow.
