Report on

Road Safety Audit of Pilot BRTS Corridor at Pune

Submitted to
Pune Municipal Corporation

Submitted by
Transportation Systems Engineering Group
Department of Civil Engineering
Indian Institute of Technology Bombay
Powai, Mumbai - 400 076

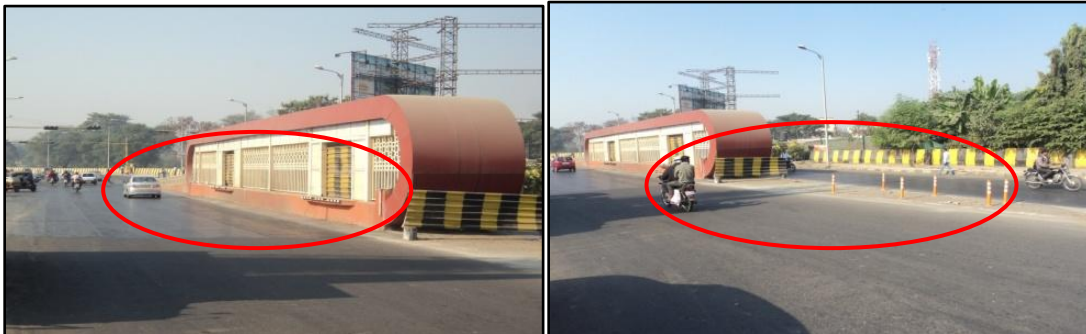
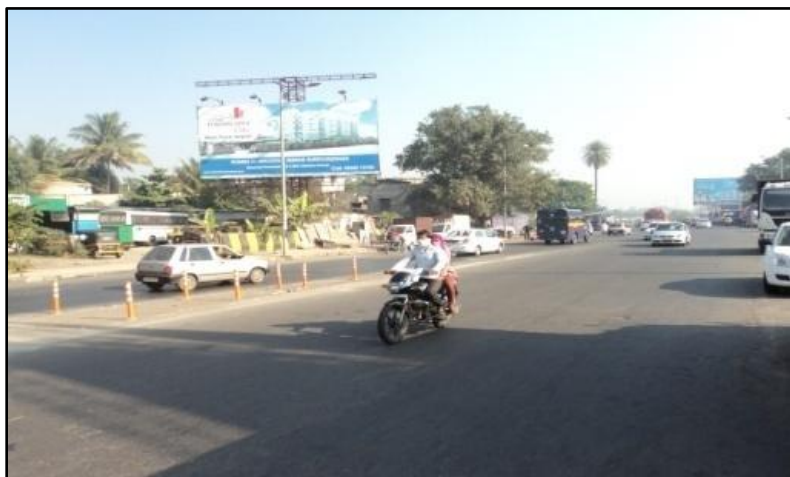
Observation 69: Barricade for BRTS lane missing for one-side bus stop near inter-city terminal

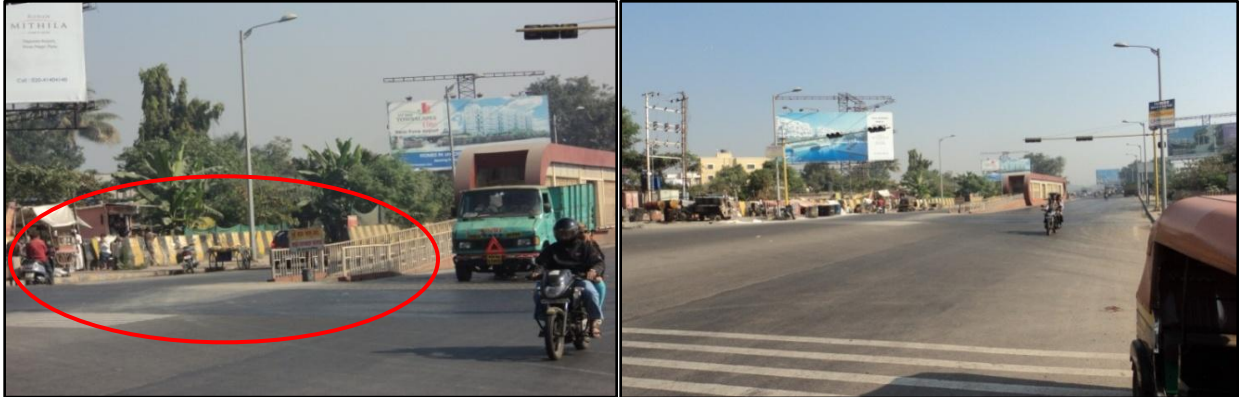
Observation 70: The lane width is narrow considering movement of vehicles taking left turn from lane going inside the residential area, vehicles taking right turn from intercity terminal and movement of BRTS. Absence of BRTS signal .

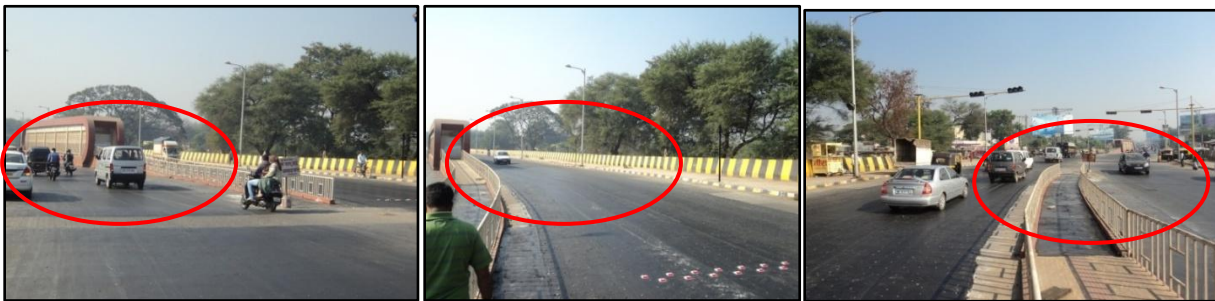
Observation 71: Barricade for BRTS lane missing for one-side bus stop near inter-city terminal

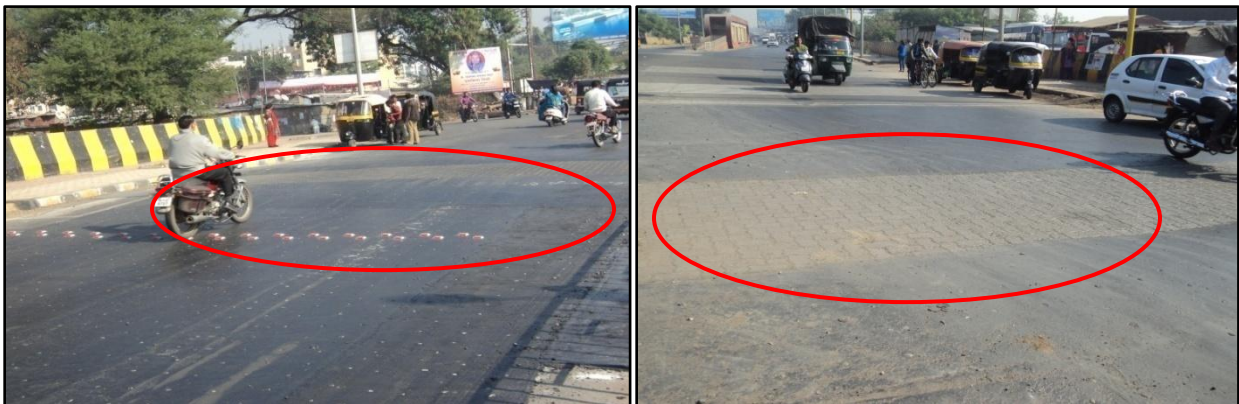
Observation 72: Pedestrian cross walk facility missing near intercity bus terminal

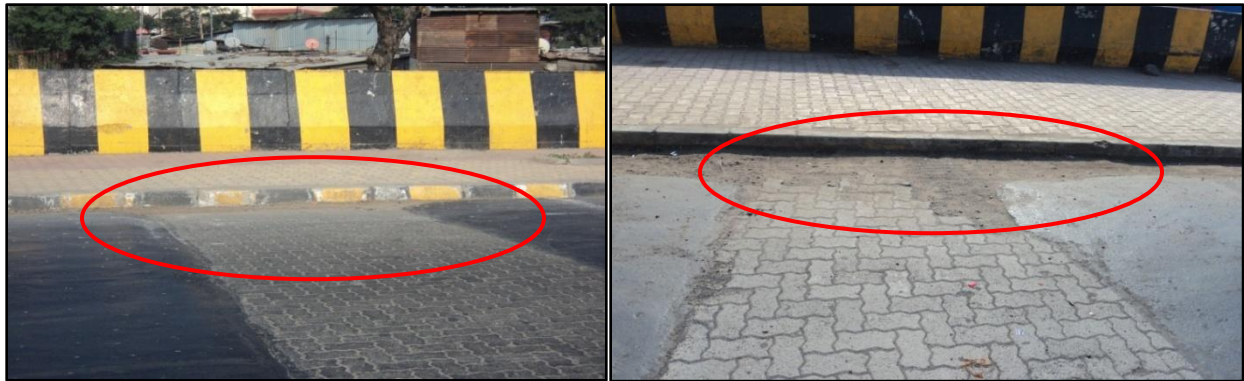
Observation 73: Improper leveling will cause difficulty for physically challenged people to access footpath through pedestrian cross walk

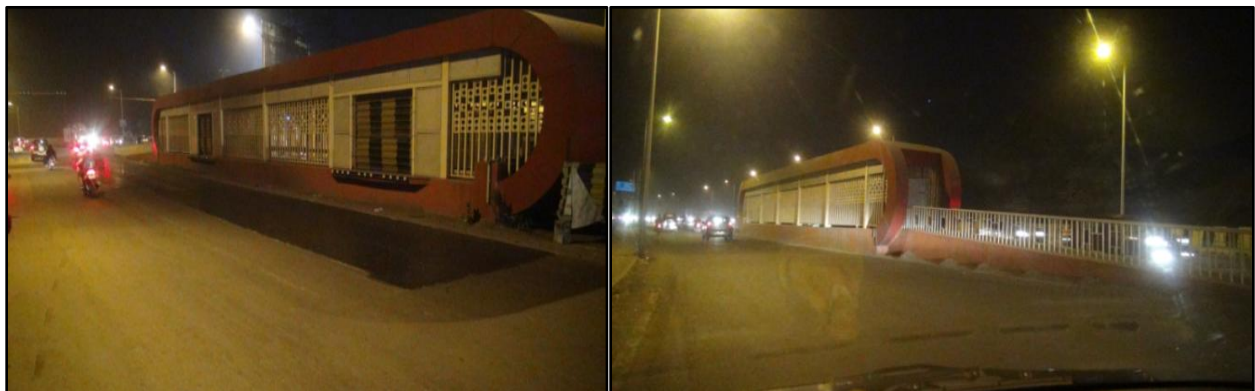
Observation 74: BRT lane reflectors and markings/highlights are missing

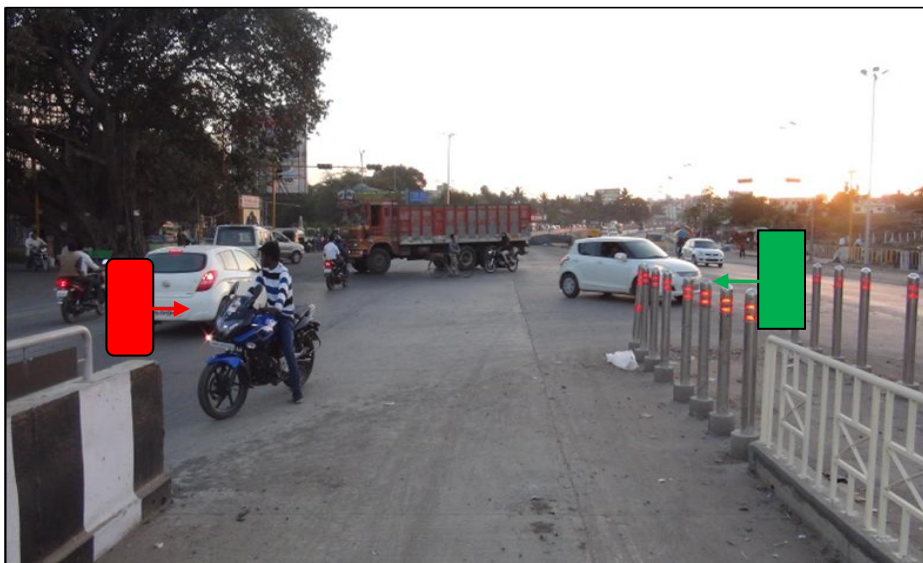
Issue 1: Improper pedestrian facilities at intersections including bus stations

Glimpse of current scenario at Indian Oil petrol bunk junction, Kharadi

If the intersections are not properly designed there can be conflicts between BRT and other modes. Improperly or un-designed intersections will create chaos between all the modes, BRT and pedestrians causing congestion, reducing efficiency and increasing chances of accidents. High speed moving BRT and vehicles trying to change lane at intersections can cause conflict if proper markings, directions to maintain segregation is not done. Example of such a kind of unplanned intersection is the one present near mental corner junction. Intersections can be designed with proper signal / markings/ round or square about to keep traffic organized and mitigate risk. All pedestrian facilities should be paid attention to by involving pedestrian crossing platform, sign boards, signals etc.

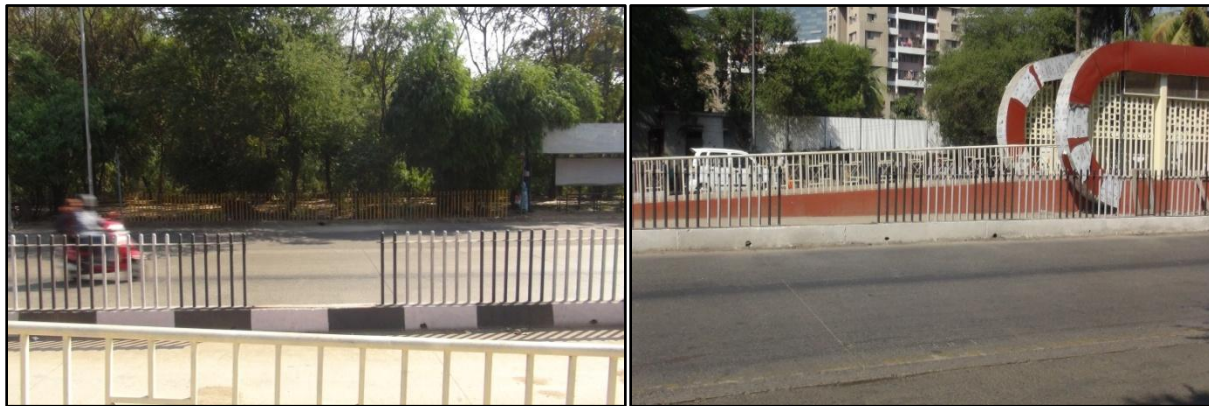
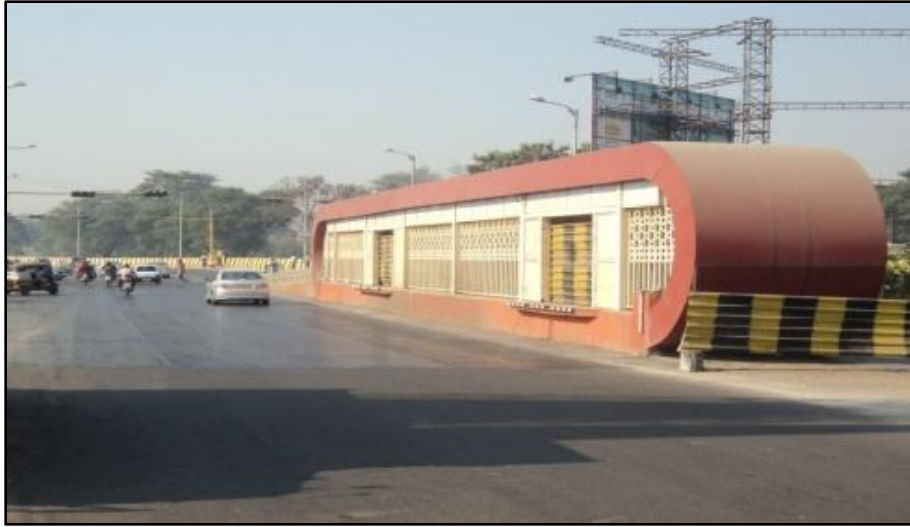
Issue 3: Improper/ absence of barricading

- This open barricading can be used by pedestrians for crossing or for reaching the bus station quickly, which can be unsafe.
- During the time of high traffic congestion or traffic jam, vehicles can enter the BRTS corridor through this which can cause accidents if BRTS is active.
- Vehicles may enter the BRTS corridor causing mixed traffic zones.

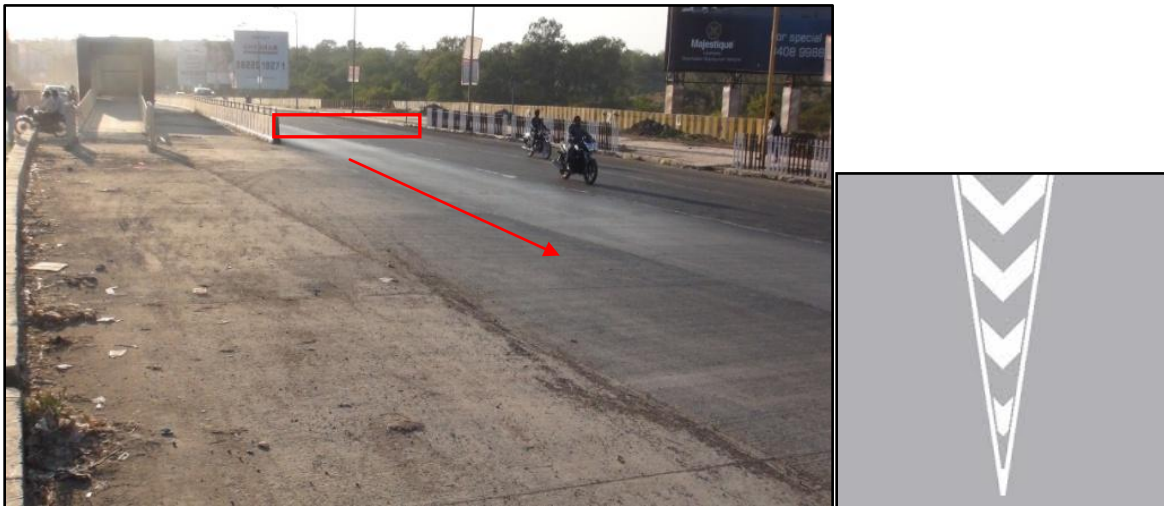
Issue 4: Absence of Rumble Strips on Service Lanes near Intersections

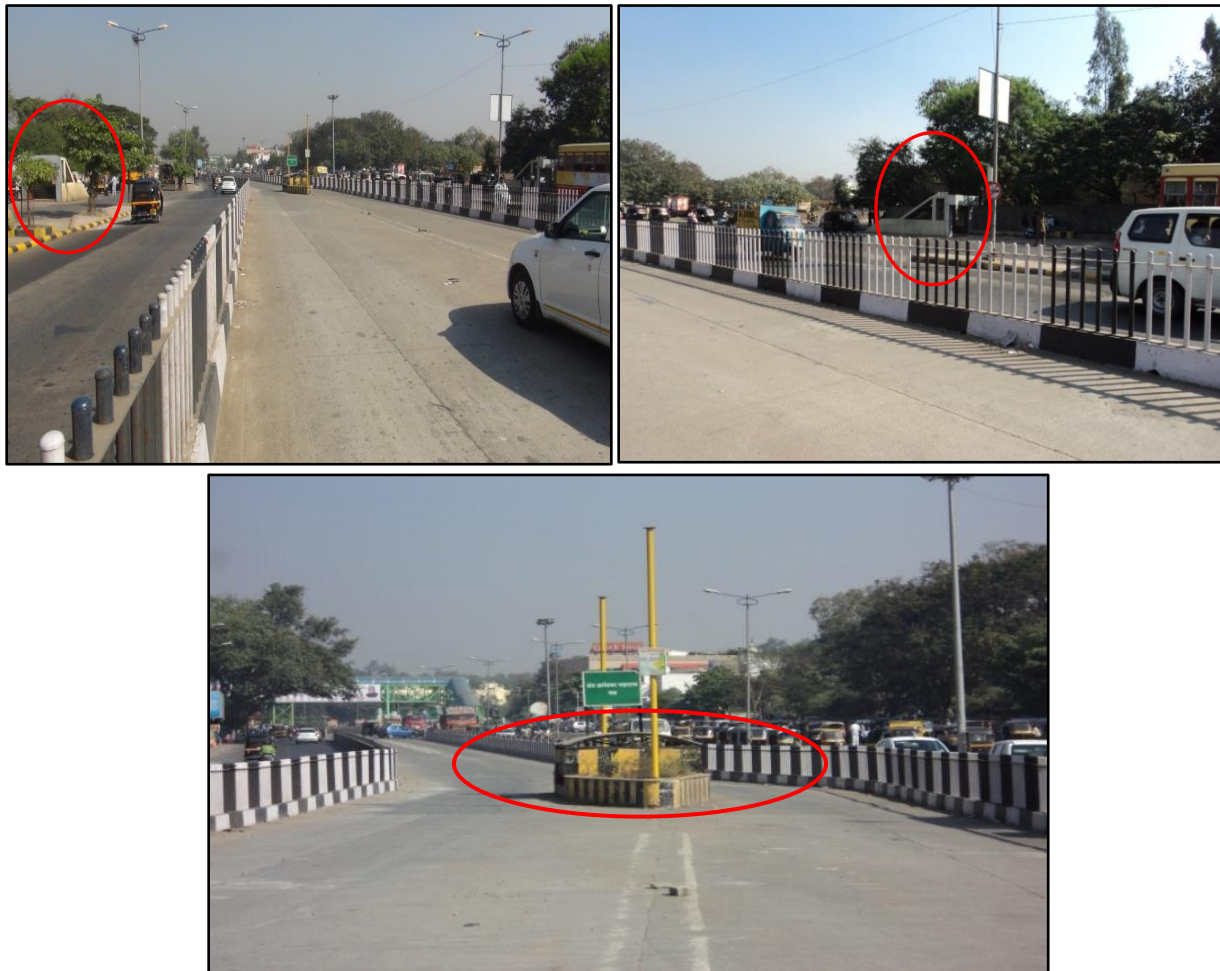
Issue 5: Lack of Subway- BRTS lane Accessibility

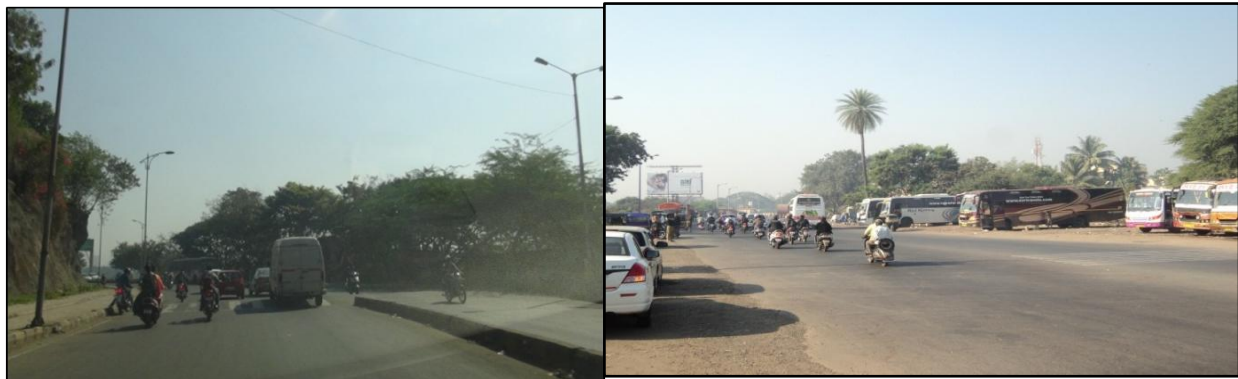
Issue 6: Presence of mix-traffic zones

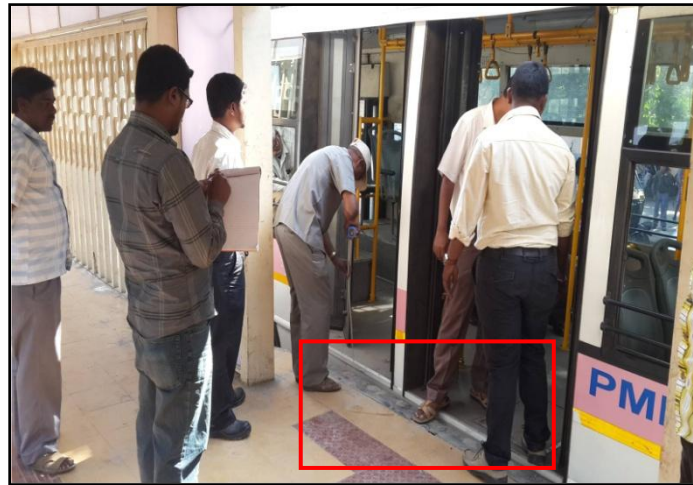
As per the information shared by PMC officials the gap observed during pilot run on level boarding is shown below:

Reduce the space between bus and platform to nominal size for all passengers, through different methods of gap reduction. A 10 cm horizontal gap is the absolute maximum and smaller horizontal gaps are highly desirable. Vertical gaps should be minimized as much as possible and it should be no more than 1-2 centimetres. Doors should be operated by sensors to prevent people from getting hit by buses. The doors should only open when a bus arrives, and all buses stops should be in perfect alignment with the shelters. Automatic doors should be installed for all the bus stations.
